NEWS BRIEFING

Office of the Assistant Secretary of Defense
(Public Affairs)

Secretary of Defense William J. Perry
General John Shalikashvili, USA, Chairman of the Joint Chiefs of Staff
Major General James Andrus, USAF, 3rd Air Force Commander
Ms. Kathleen M. deLaski, ATSD (PA)
Wednesday, July 13, 1994 - 2:15 p.m.

We are here today to present you with the findings of the Department into the circumstances surrounding the tragic incident in Northern Iraq in which two of our fighters accidentally shot down two of our helicopters.

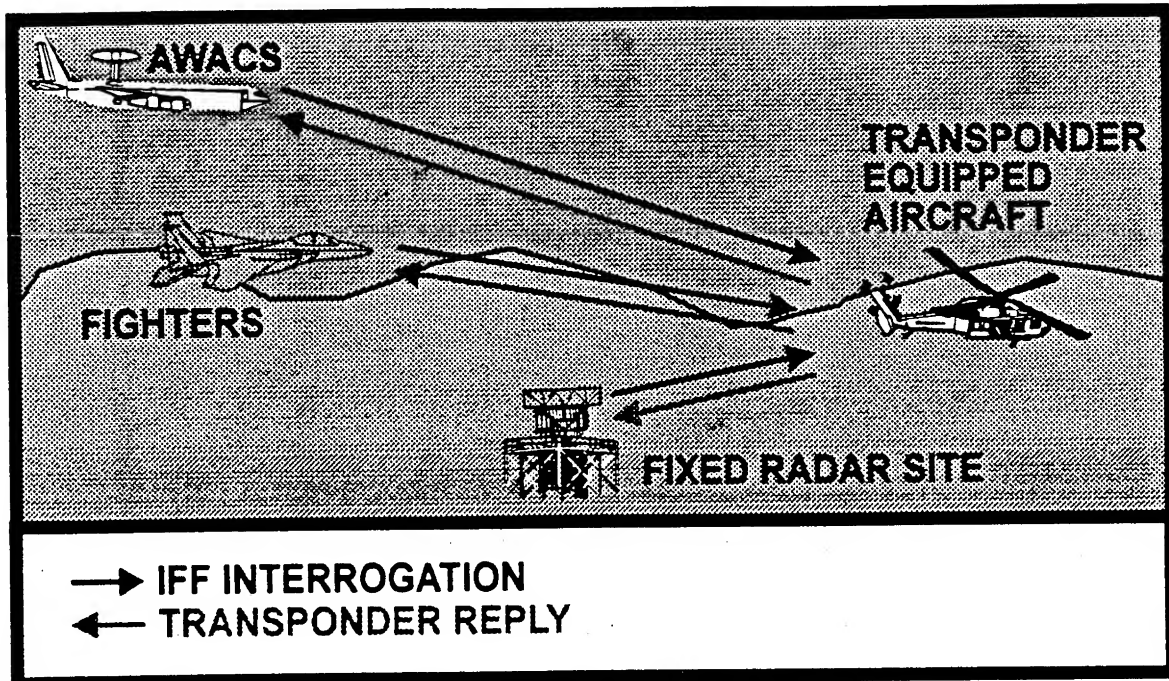
FACT SHEET
INFORMATION FRIEND OR FOE (IFF) SYSTEM

THE IFF SYSTEM IS USED TO IDENTIFY INDIVIDUAL AIRCRAFT OR FLIGHTS, PARTICIPATING IN OPERATION PROVIDE COMFORT. THERE ARE TWO INTERACTING COMPONENTS OF THE SYSTEM: A TRANSPONDER AND AN INTERROGATOR. EACH COALITION AIRCRAFT IS EQUIPPED WITH AN IFF TRANSPONDER. WHEN THE TRANSPONDER IS INTERROGATED FROM A GROUND OR AIRBORNE SOURCE, IT WILL RESPOND WITH A NUMERICALLY IDENTIFIABLE PULSE. EACH TRANSPONDER CAN REPLY IN SEPARATE MODES. EACH MODE CAN BE PROGRAMMED TO REPLY WITH A SEPERATE NUMERIC CODE. THESE REPLIES ARE DISPLAYED ON A RADAR SCOPE.

<u>MODE</u>	<u>CODE</u>	<u>OPC AIRCRAFT</u>
I	42	HELICOPTER OUTSIDE TAOR
	43	FIXED WING OUTSIDE TAOR
	52	ALL AIRCRAFT INSIDE TAOR
II	5530	BLACKHAWK LEAD
	5531	BLACKHAWK WING
IV	ENCRYPTED	ALL AIRCRAFT
